Borehole Logging Survey Residential Well and RW-1 108 Spencer Road

April 8, 2025

RE: Borehole Logging Survey  
Residential Well and RW-1  
108 Spencer Road  
Upper Makefield Township, PA  
RETTEW Project No. 0963003386

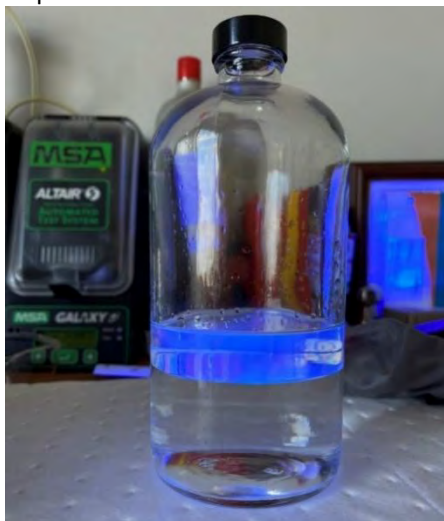
*Figure 2: Jet A fuel floating on water illuminated by 365 nm UV flashlight. Photo courtesy of Bill Barth (ET).*

Benchtop testing by ET has demonstrated that jet fuel will fluoresce bright blue under 365 nm excitation (see **Figure 2**).
